# **FATIGUE BEHAVIOUR OF HIC DAMAGED LINE PIPE STEEL**

**RAKAN ABDULLAH AL-SHAMMARY**

**KING FAHD UNIVERSITY OF PETROLEUM & MINERALS**

**MAY 2005**

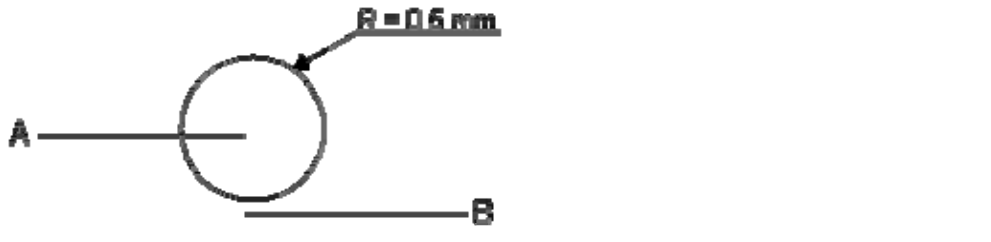
If cracks A and B are separated by more than 0.5 mm, then they are measured as two separate cracks.

If the distance is less than 0.5 mm, then cracks A and B are considered as a single crack in the measurement.

**Figure 5.2: Method for measuring and evaluating cracks on a metallograph**

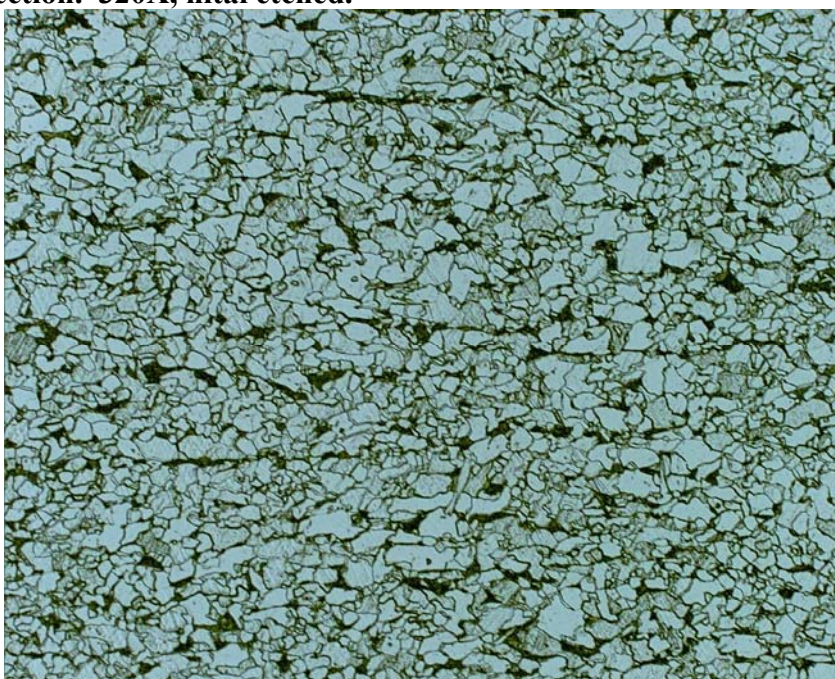
**Figure 6.6: Micrograph of sample B'4, transverse to the rolling direction of Grade X-42 steel. 200X, nital etched.**

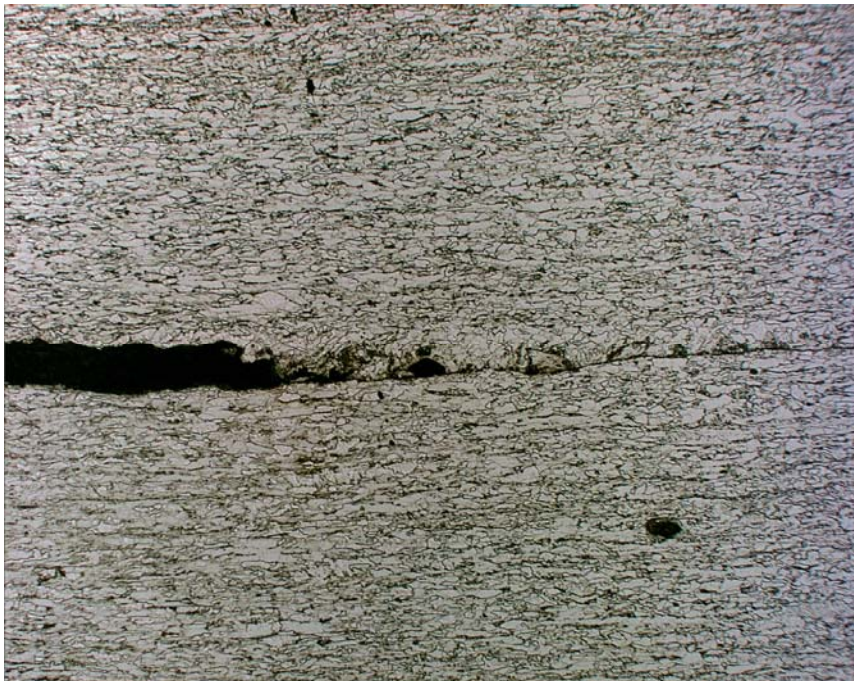
**Figure 6.14: Micrograph of sample C'6 showing cracking along banding at a magnification of X125, nital etched.**

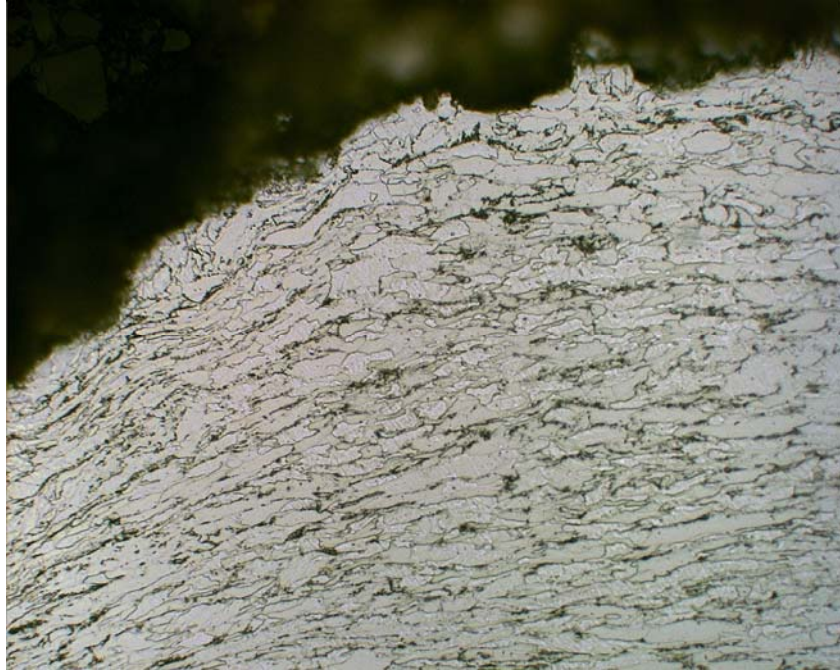
**Figure 6.15: Micrograph of sample C'6 at a magnification of X320 showing deformation of the microstructure near the fracture.**

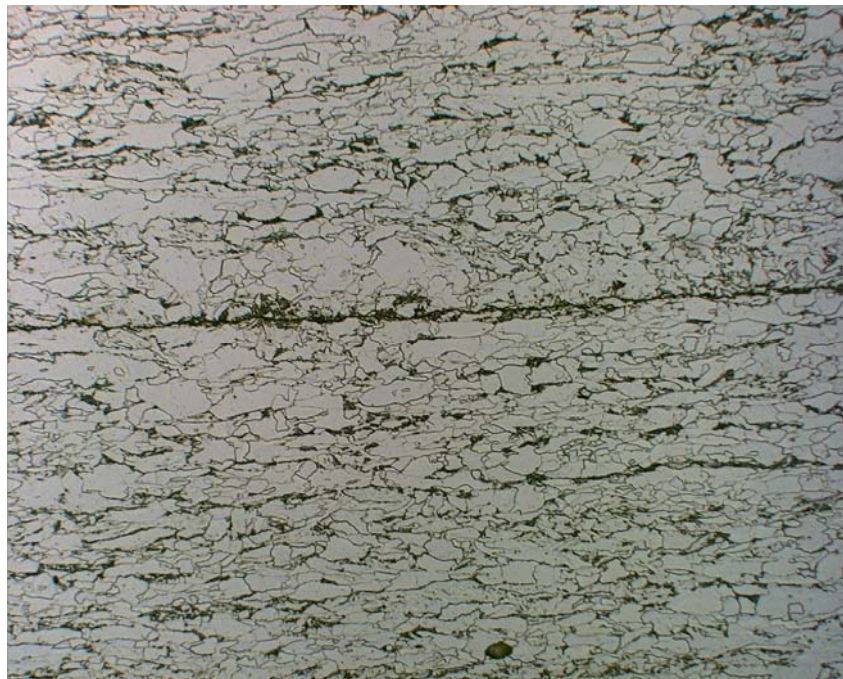
**Figure 6.16: Sample C'6 away from the fracture showing undeformed microstructure with a crack initiating along banding, X320.**

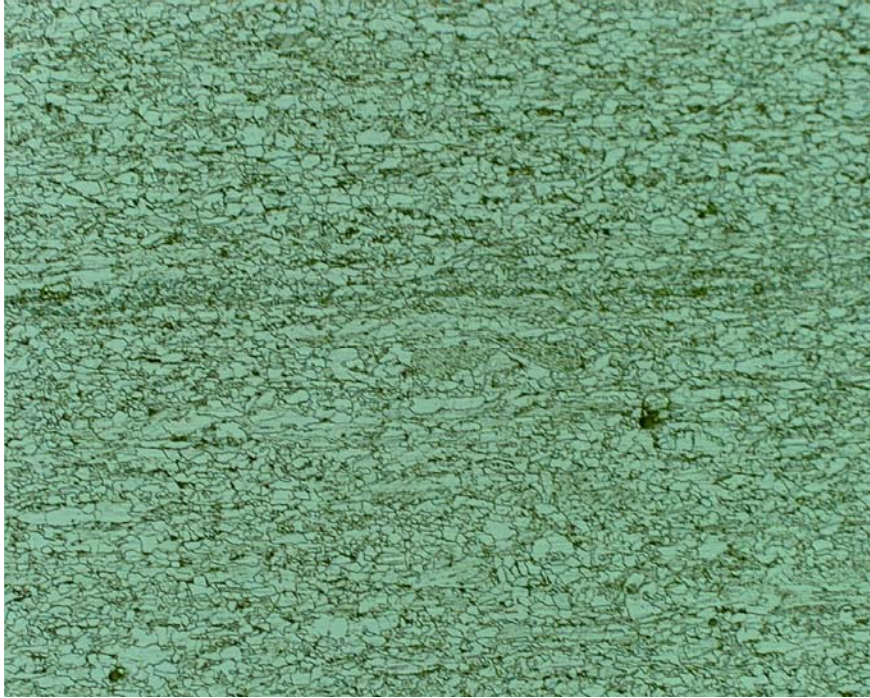
**Figure 6.19: Micrograph showing the microstructure of sample C'2 with lamination at the center. Magnification 200X, nital etched.**

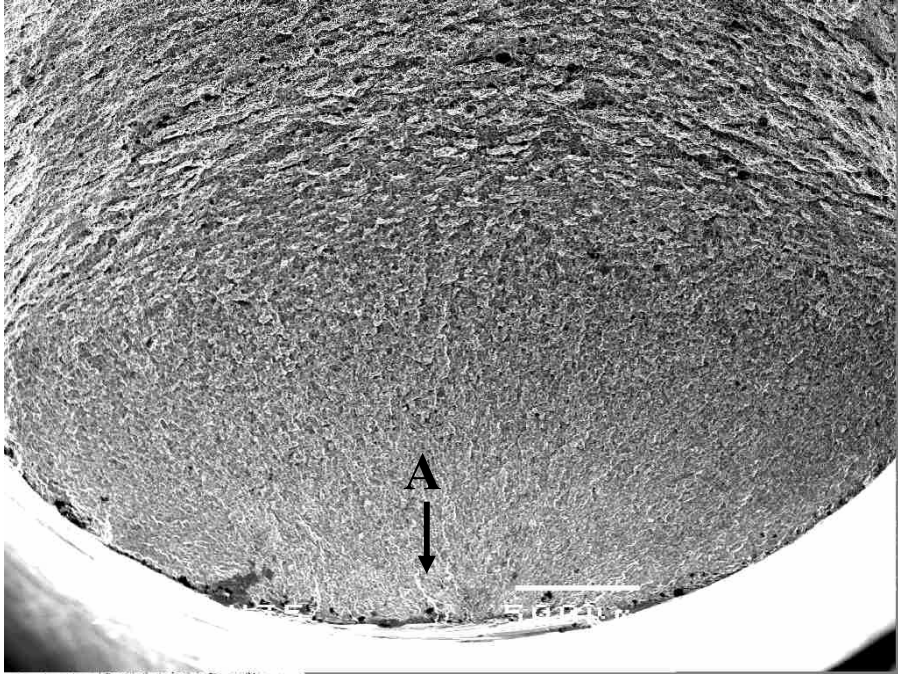
**Figure 6.46: SEM photograph of the fracture initiation site of area A in figure 6.45 at 35X. The arrow points to the crack initiation site.**
